Buffalo River Area of Concern: A Case Study for Building Partnerships to Address Local Environmental Problems

Jill Singer, Department of Earth Sciences, Buffalo State College · Barry Boyer, Law School, SUNY-Buffalo

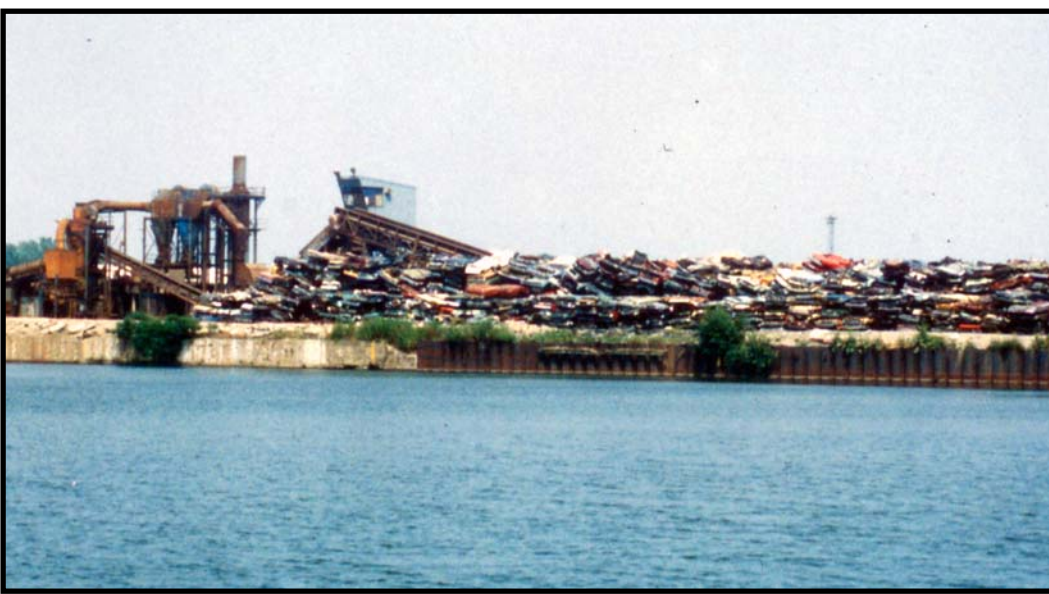
Figures: top left: historic view taken near the mouth of the Buffalo River; middle left: active grain elevators line the lower portion of the river; bottom left: a metal reclamation yard located along the banks of the river; top right: view of the meandering Buffalo River, the Buffalo River AOC begins just below the convergence of the two creeks; middle right: aerial view of the river; bottom right: an upstream industry (Buffalo Color Corp) that is presently inactive.

The Buffalo River flows along the southern boundary of the City of Buffalo and its watershed includes both agricultural and urban areas. As the Buffalo River enters Buffalo on its way into Lake Erie, the riverbanks are lined with active and abandoned industrial sites. A bird's eye view of the river (rt. middle figure) shows the prominent grain elevators (only the lowermost grain elevators are still in use today) and the numerous tight meanders. Until fairly recently, numerous industries, including chemical, steel, and oil refining, routinely discharged metals and organic compounds into the river. Today, most of the industry either has shut down or decreased production, and all operating facilities are subject to stricter environmental controls. The legacy of the past has led to the destruction of habitat, poor water quality, and the deposition of contaminated bottom sediments, and has resulted in the lower 9.2 km of the Buffalo River being included in the list of Canadian-United States Areas of Concern (AOC). For each AOC, a remedial action plan (RAP) is developed identifying the impairments and outlining measures to be taken to restore the beneficial uses of the river/harbor. In the US, the EPA is the agency responsible for coordinating and assisting the eight Great Lakes States in preparing RAPs and in New York State, the Department of Environmental Conservation (DEC) is the lead agency in the development of the Buffalo River RAP. The Buffalo River RAP committee was formed in 1986. In 1989, the Stage I RAP was submitted to the IJC (International Joint Commission) for review. Several months later, the Buffalo River Remedial Advisory Committee (RAC) was appointed to advise and assist the NYS Department of Environmental Conservation (DEC) in the implementation of the RAP.

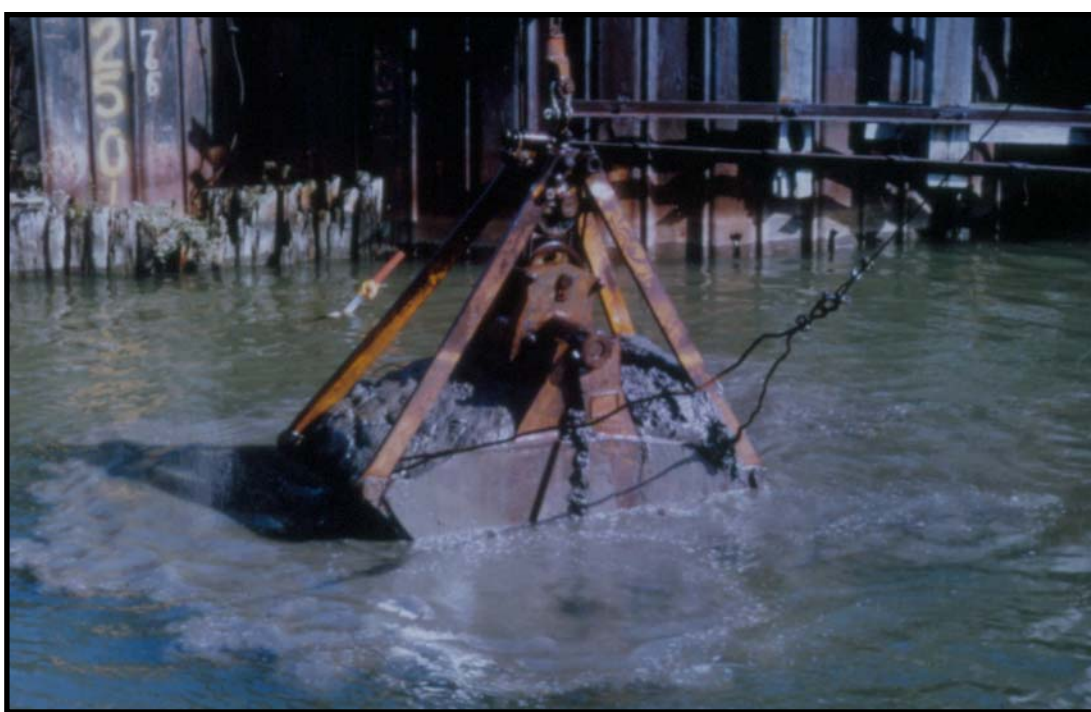
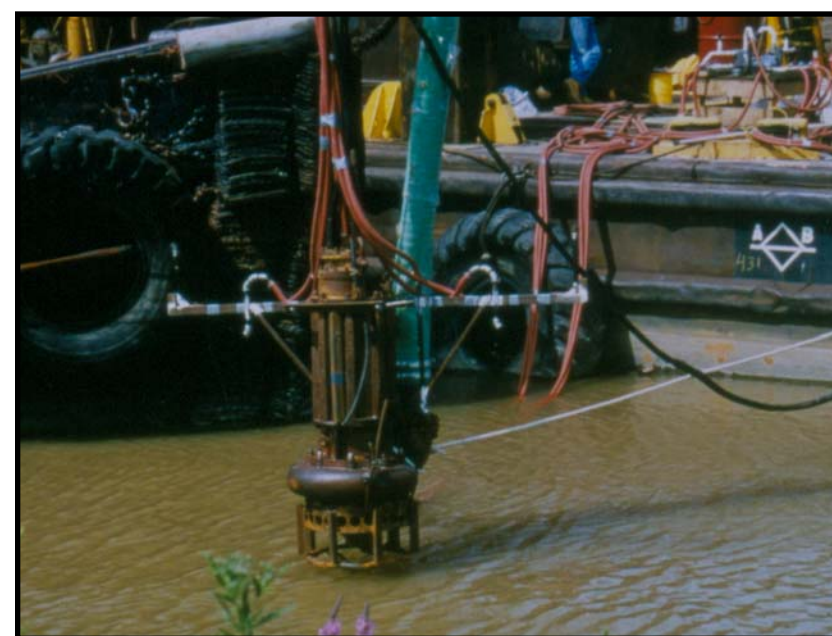
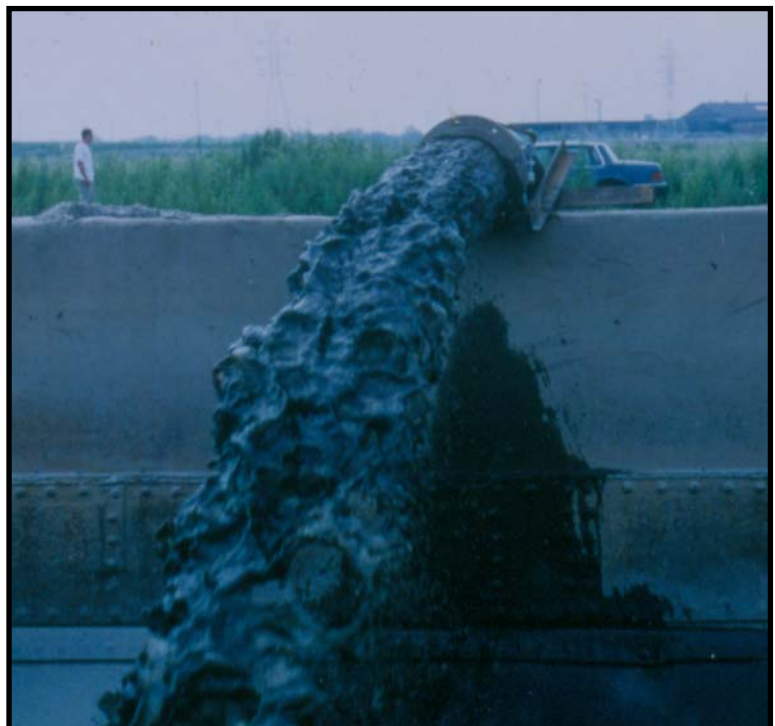
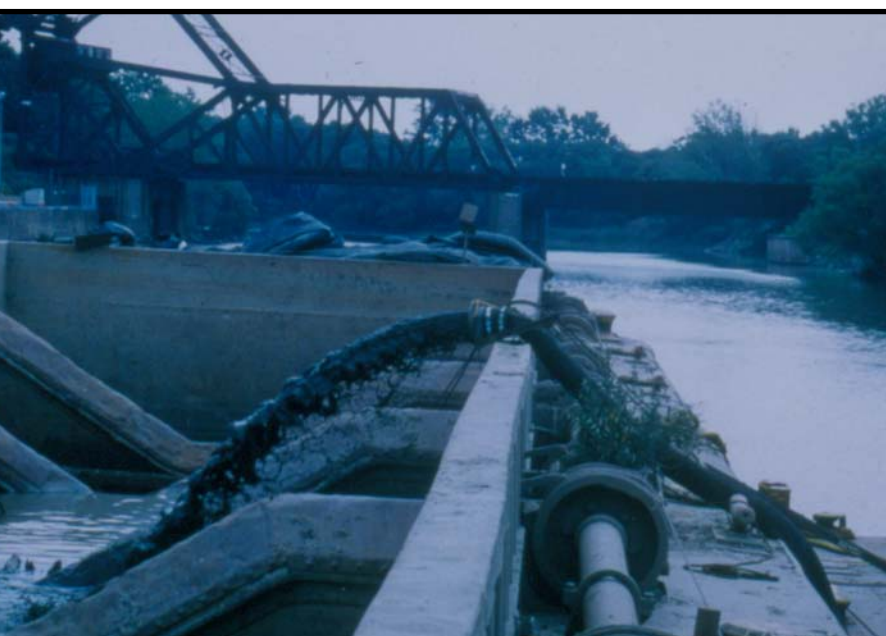
Figures: left top: pre-dredging side scan sonar; right top: slumping of sediment following navigational dredging; left bottom: side scan sonar record showing bottom morphology resulting from suction dredging; right bottom: side scan sonar record showing bottom morphology resulting from open and closed bucket dredging

Because the Buffalo River is classified as a navigational channel, it is subjected to routine maintenance dredging. In part, as a consequence of citizens' concerns raised over the use of open-bucket dredging and a desire to explore alternative methodologies, an environmental dredging conference was held in Buffalo in 1992 and an environmental dredging demonstration project undertaken. Three techniques were considered: open-bucket, closed-bucket, and suction dredging. Pre-and post-dredging side scan sonar surveys of the river bottom were done to assess changes in bottom morphology as a result of the dredge technique. Despite heavy rains that coincided with the demonstration project, the resuspension of sediment was consistent with the predictions—greatest amount of sediment resuspension occurred with open bucket dredging, the least with suction dredging. For economic reasons, no change in dredging technique has occurred despite these findings.
