GEOL 101 - INTRODUCTION TO GEOLOGY

1993 Missouri River Flood Exercise

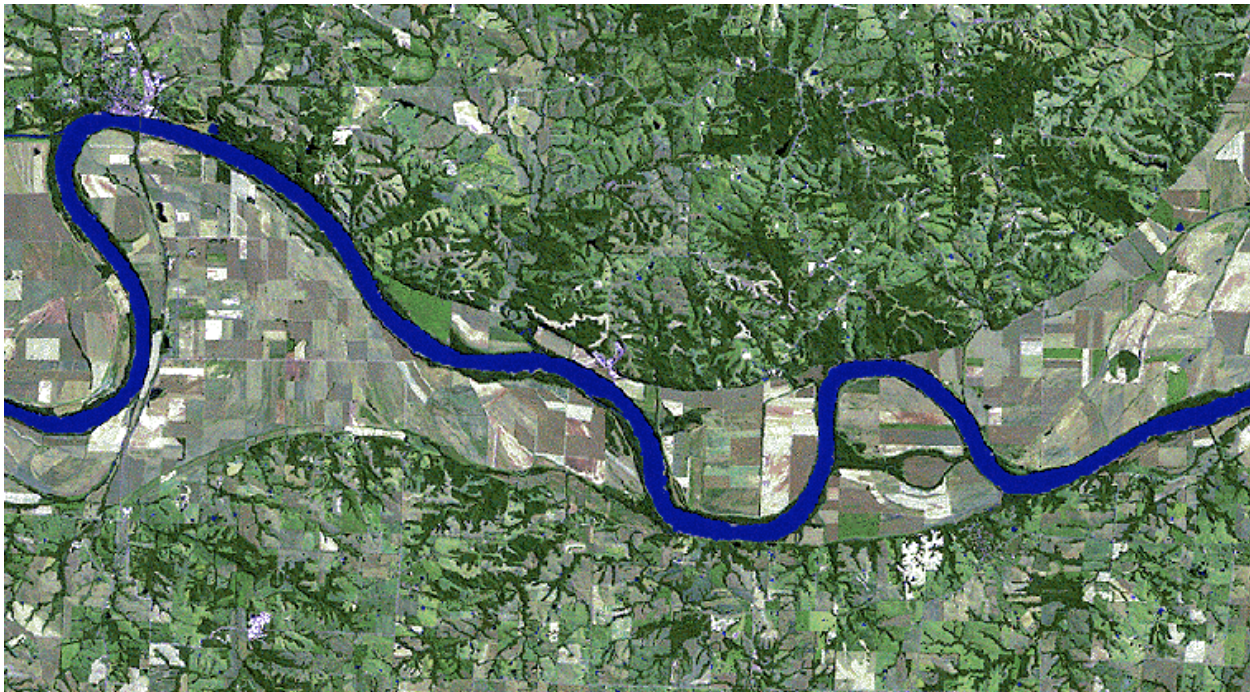
(Slide 1) Pre-flood image (September 24, 1992):

1. Most of the floodplain was being used for agriculture (note the regular pattern of rectangular fields). What features of river floodplains make them particularly attractive for agricultural use?
2. Examine the floodplain closely (note the distinct tree-covered bluffs that mark the boundaries of the floodplain). Do you see any patterns or features that represent older abandoned river channel segments? These might appear as curving tree lines or curved scar-like patterns in the vegetation. Describe what you see.

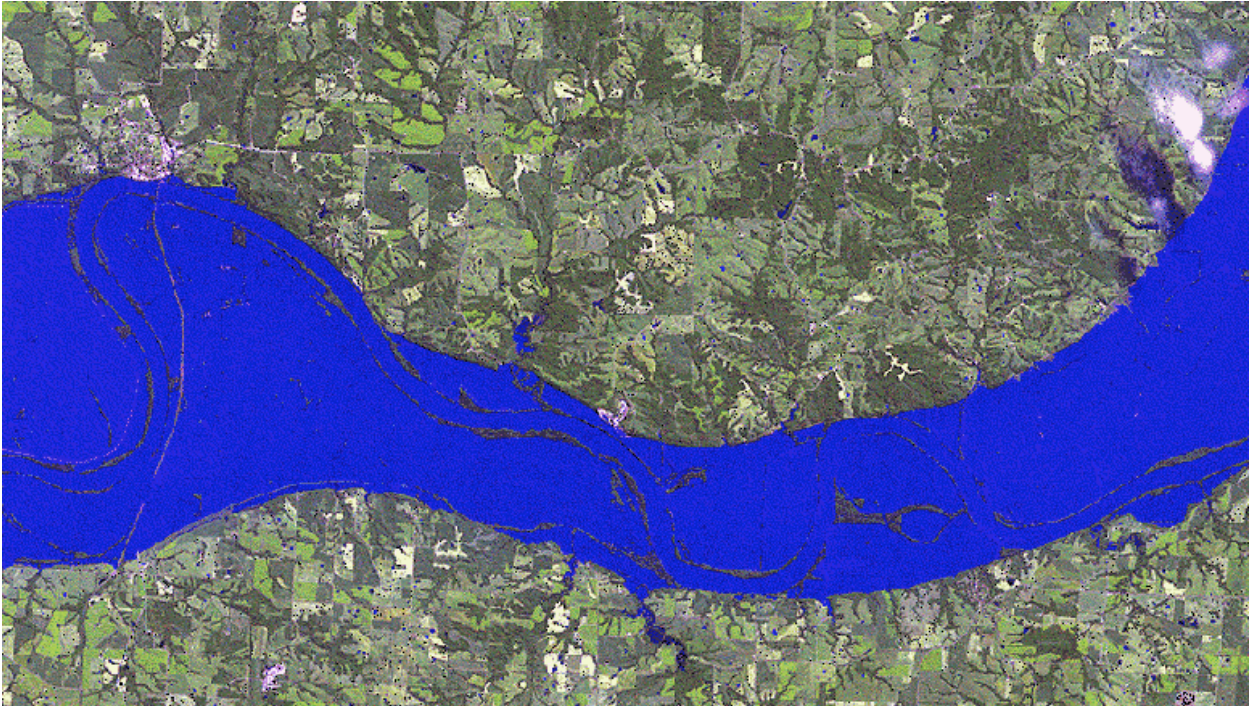
(Slide 2) Peak flood image (August 1, 1993):

3. Note that the “normal” flow channel is still visible in most of the photo, from the vegetation growing on the levees. You should be able to find several places where the levees have been breached. How many levee breaks can you find? (You can verify your hypothesis by looking at the next photo in the sequence.)
4. Notice that the breaks in the levees seem to be associated with the bends in the river channel. What happens to the water flow as the current moves through a bend which might make levees on the bends more susceptible to failure than the levees on the straight channel segments?
