# 1976 Big Thompson Flood, Colorado —

## Thirty Years Later

This fact sheet (FS-2006–3095) and accompanying poster (General Information Product 35) and other publications can be ordered from the USGS Store at <http://store.usgs.gov> or call 1-888-ASK-USGS (1-888-275-8747).

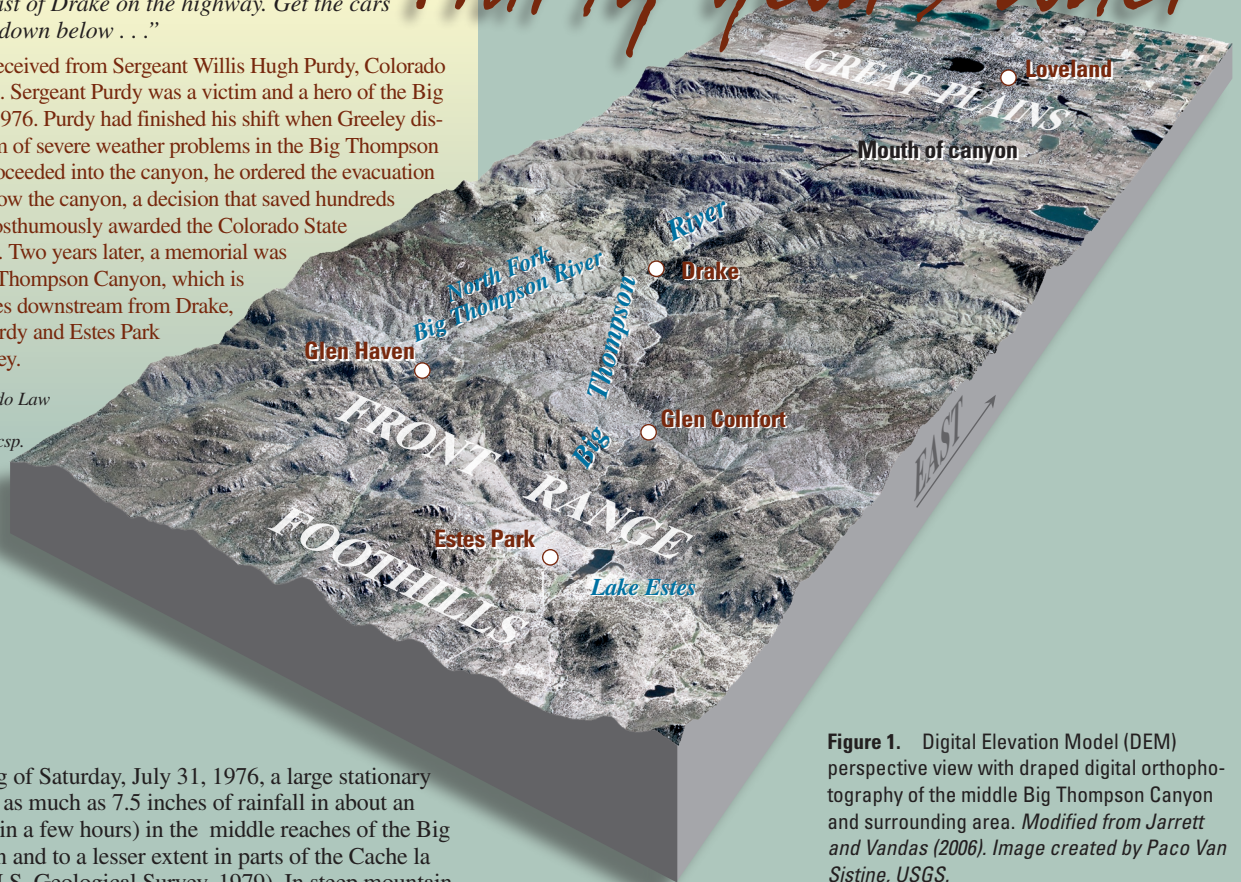
**Figure 1.** Digital Elevation Model (DEM) perspective view with draped digital orthophotography of the middle Big Thompson Canyon and surrounding area. Modified from Jarrett and Vandas (2006). Image created by Paco Van Sistine, USGS.

The topography of the affected area is characterized by narrow canyons bordered by steep, rocky, mountain slopes (fig. 1). On July 31, 1976, a moist airmass began pushing westward from the Great Plains on the east side of the Rockies. During the afternoon, the moist air rose up the mountain slopes and the unstable air began to build into thunderstorms; a schematic illustration showing the cause of the storm and flood is provided in figure 2. Large thunderstorms formed along the Front Range and began to dump heavy rain on the region about 6:30 p.m. This event turned deadly when high-altitude westerly winds, which are usually strong enough to push thunderstorms eastward and out of the area, were unusually weak. The thunderstorms stalled for more than 3 hours over the Big Thompson Canyon, and built into a gigantic thunderstorm system. The thunderstorms produced as much as 12–14 inches of

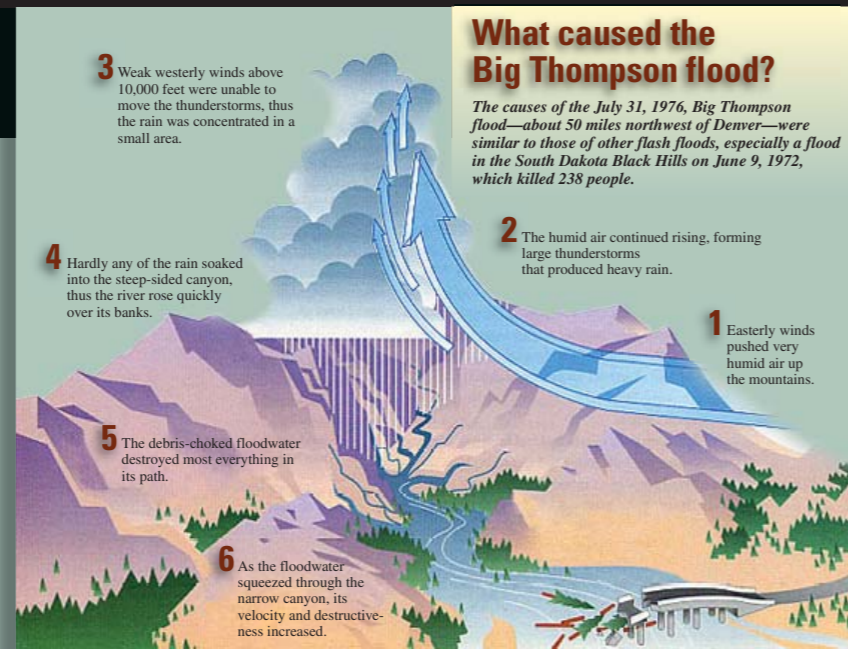
**Figure 2.** Schematic diagram showing what caused the Big Thompson flood. Modified from the University Corporation for Atmospheric Research.

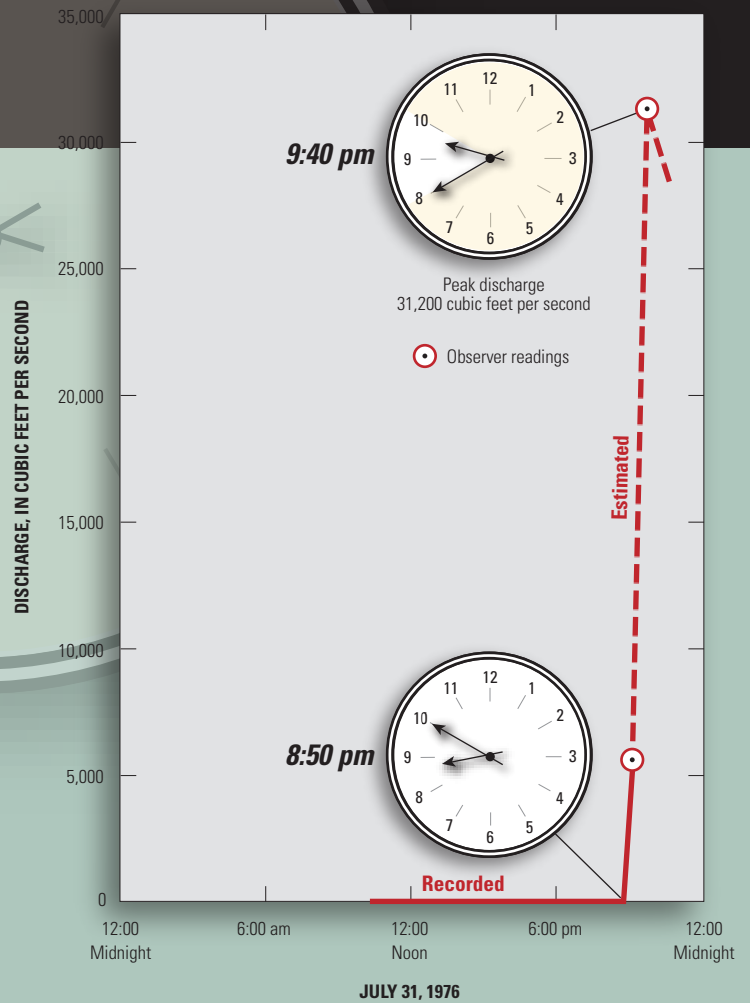
**Figure 4.** Hydrograph showing the discharge of the Big Thompson River at the mouth of the canyon near Drake (site G in table 1 and on fig. 3); the hydrograph is estimated because the gage was destroyed by the record flood. Modified from U.S. Geological Survey (1979).

Peak discharges were extremely large on many streams in and downstream from the storm's rainfall center. The peak discharge estimated at the streamflow-gaging station located on the Big Thompson River at the mouth of the canyon near Drake was 31,200 ft<sup>3</sup>/s (cubic feet per second); this was almost 4 times the previous maximum discharge of 8,000 ft<sup>3</sup>/s since record keeping began in 1887 (table 1). River depths went from a few feet to nearly 20 feet, and peak discharges occurred in less than an hour along many reaches of the Big Thompson Canyon (fig. 4). The peak discharges for three tributaries near the area of heaviest rainfall exceeded previous recorded maximum discharges for basins less than 4 square miles in Colorado (U.S. Geological

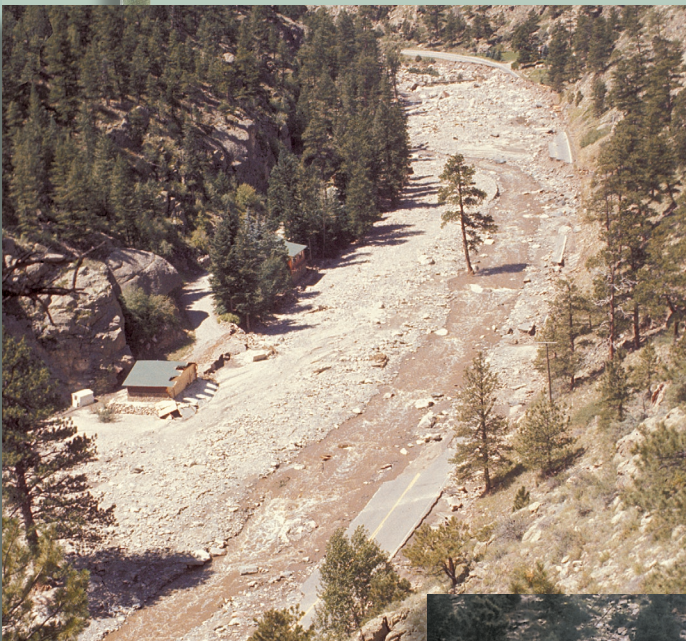
**Figure 7 (Above).** Upstream view of the Big Thompson River showing extreme flood damage to U.S. Highway 34 upstream from Drake. The U.S. Geological Survey estimated the flood's peak discharge to be 28,200 cubic feet per second in this area.

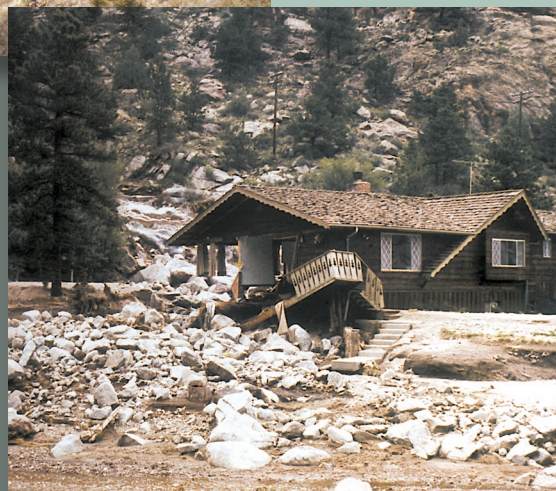
**Figure 8 (Right).** This house was built on an alluvial fan that was produced by sediment discharged from a side canyon to the Big Thompson River. Floodwaters from the side canyon damaged part of the house and pushed it about 4 feet off its foundation.

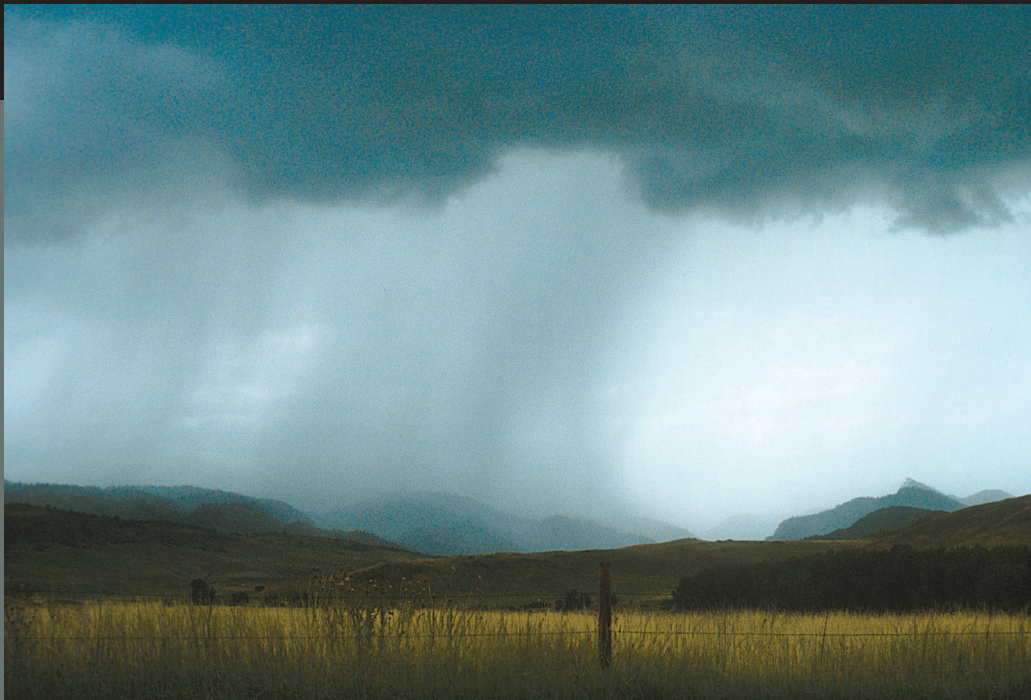
**Figure 9.** Growing thunderstorm clouds and rain forewarn of potentially severe weather conditions including lightning, intense rainfall, hail, flooding, and tornadoes. Monitoring the development and movement of such clouds, as well as awareness of weather forecasts, can help people prepare for potentially hazardous conditions. *Photograph courtesy of Lester Zinser, University Corporation for Atmospheric Research.*

Nature often provides early warning signs of impending hazardous flooding. Knowledge and observation of developing thunderstorms (fig. 9) can provide important early warning in areas subject to lightning, hail, tornadoes, and flood-producing rains. In some cases, such as during the July 1976 flood in the Big Thompson Canyon downstream from Drake near the canyon mouth, there is little or no rainfall that might alert people that floodwaters are advancing. Once a flood (meteorologic or dam failure) or debris flow begins, many eyewitnesses often mention hearing rumbling sounds (described as trees breaking, jet airplanes, locomotives, and other loud roars) moving closer to their location. A combination of personal responsibility, planning and awareness, National Weather Service and other local flood agency programs and resources, and personal observations of developing weather conditions are vital to prepare people to help protect themselves when hazardous flooding is imminent.
